Los Angeles World Airports

CURTAIN WALL DETAILS AT BUS CONNECTOR

Bradley West Consultants 3300 World Way, LA, CA 90045

A7318

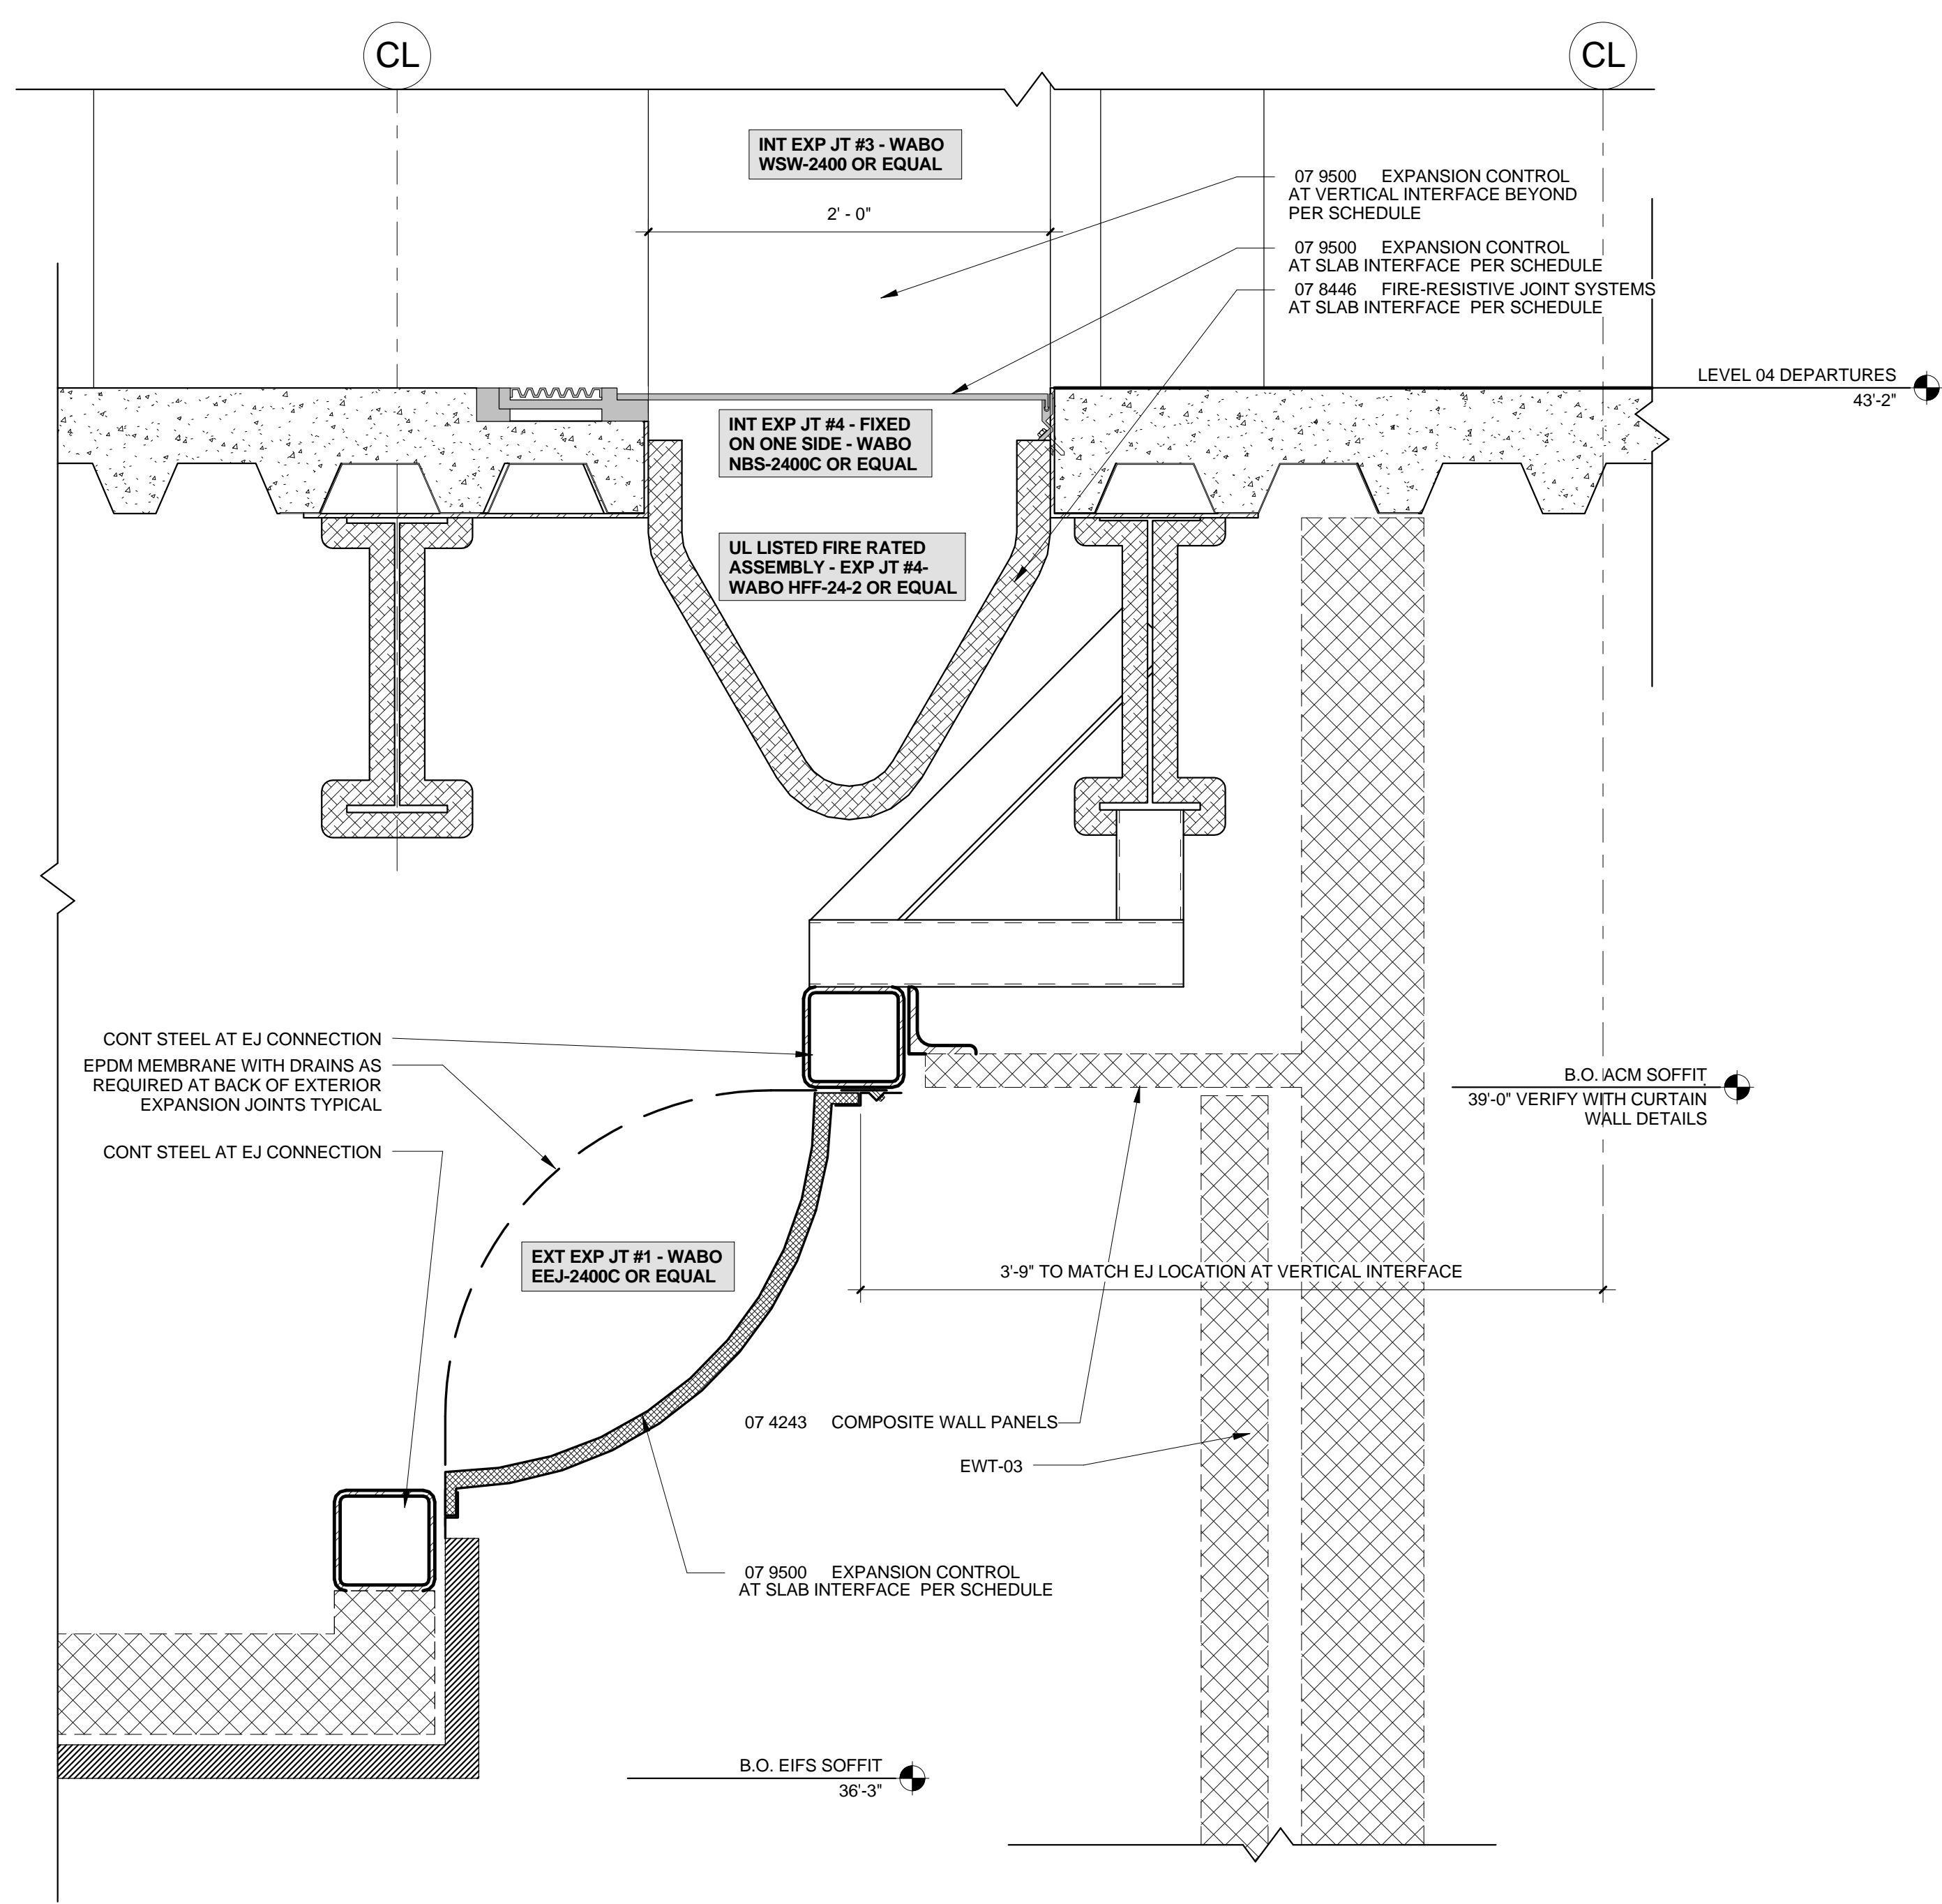
6 AS103/A7318 1 1/2" = 1'-0"

SECTION DETAIL - SEISMIC JOINTS AT LEVEL 04 INTERFACE

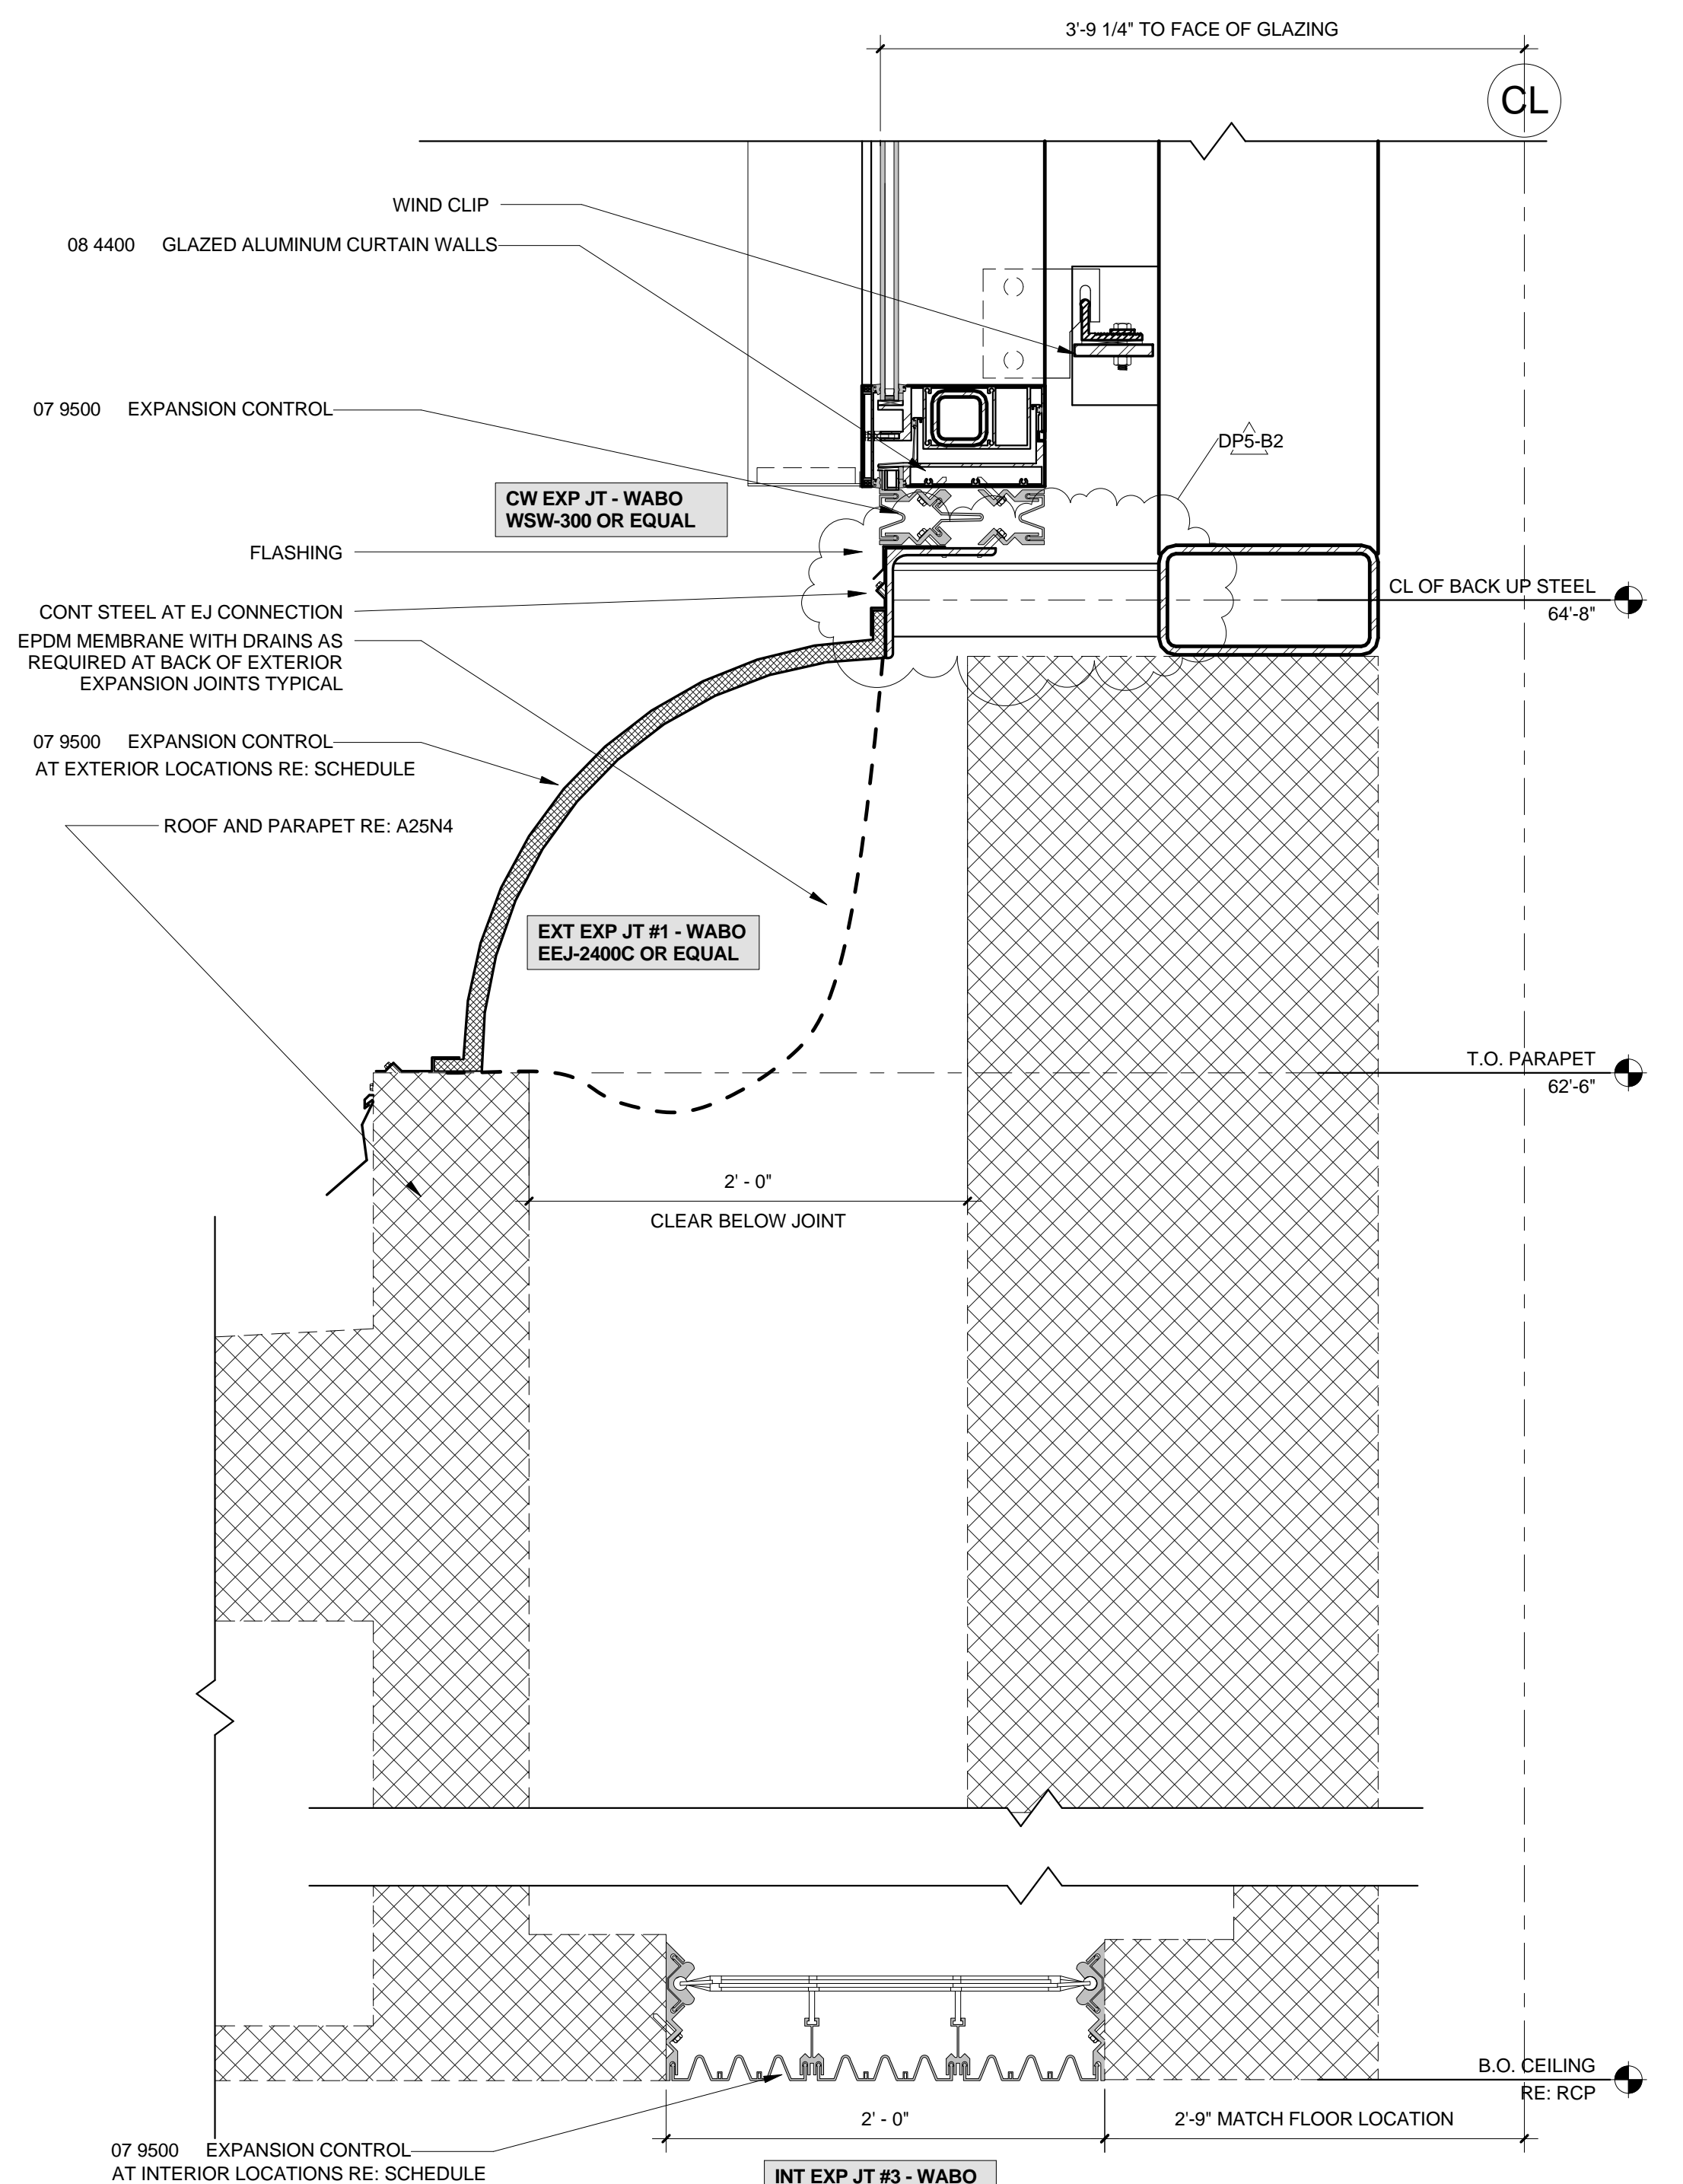
4 AS103/A7318 1 1/2" = 1'-0"

SECTION DETAIL-SEISMIC JOINTS AT BUS GATE INTERFACE AT LOW ROOF

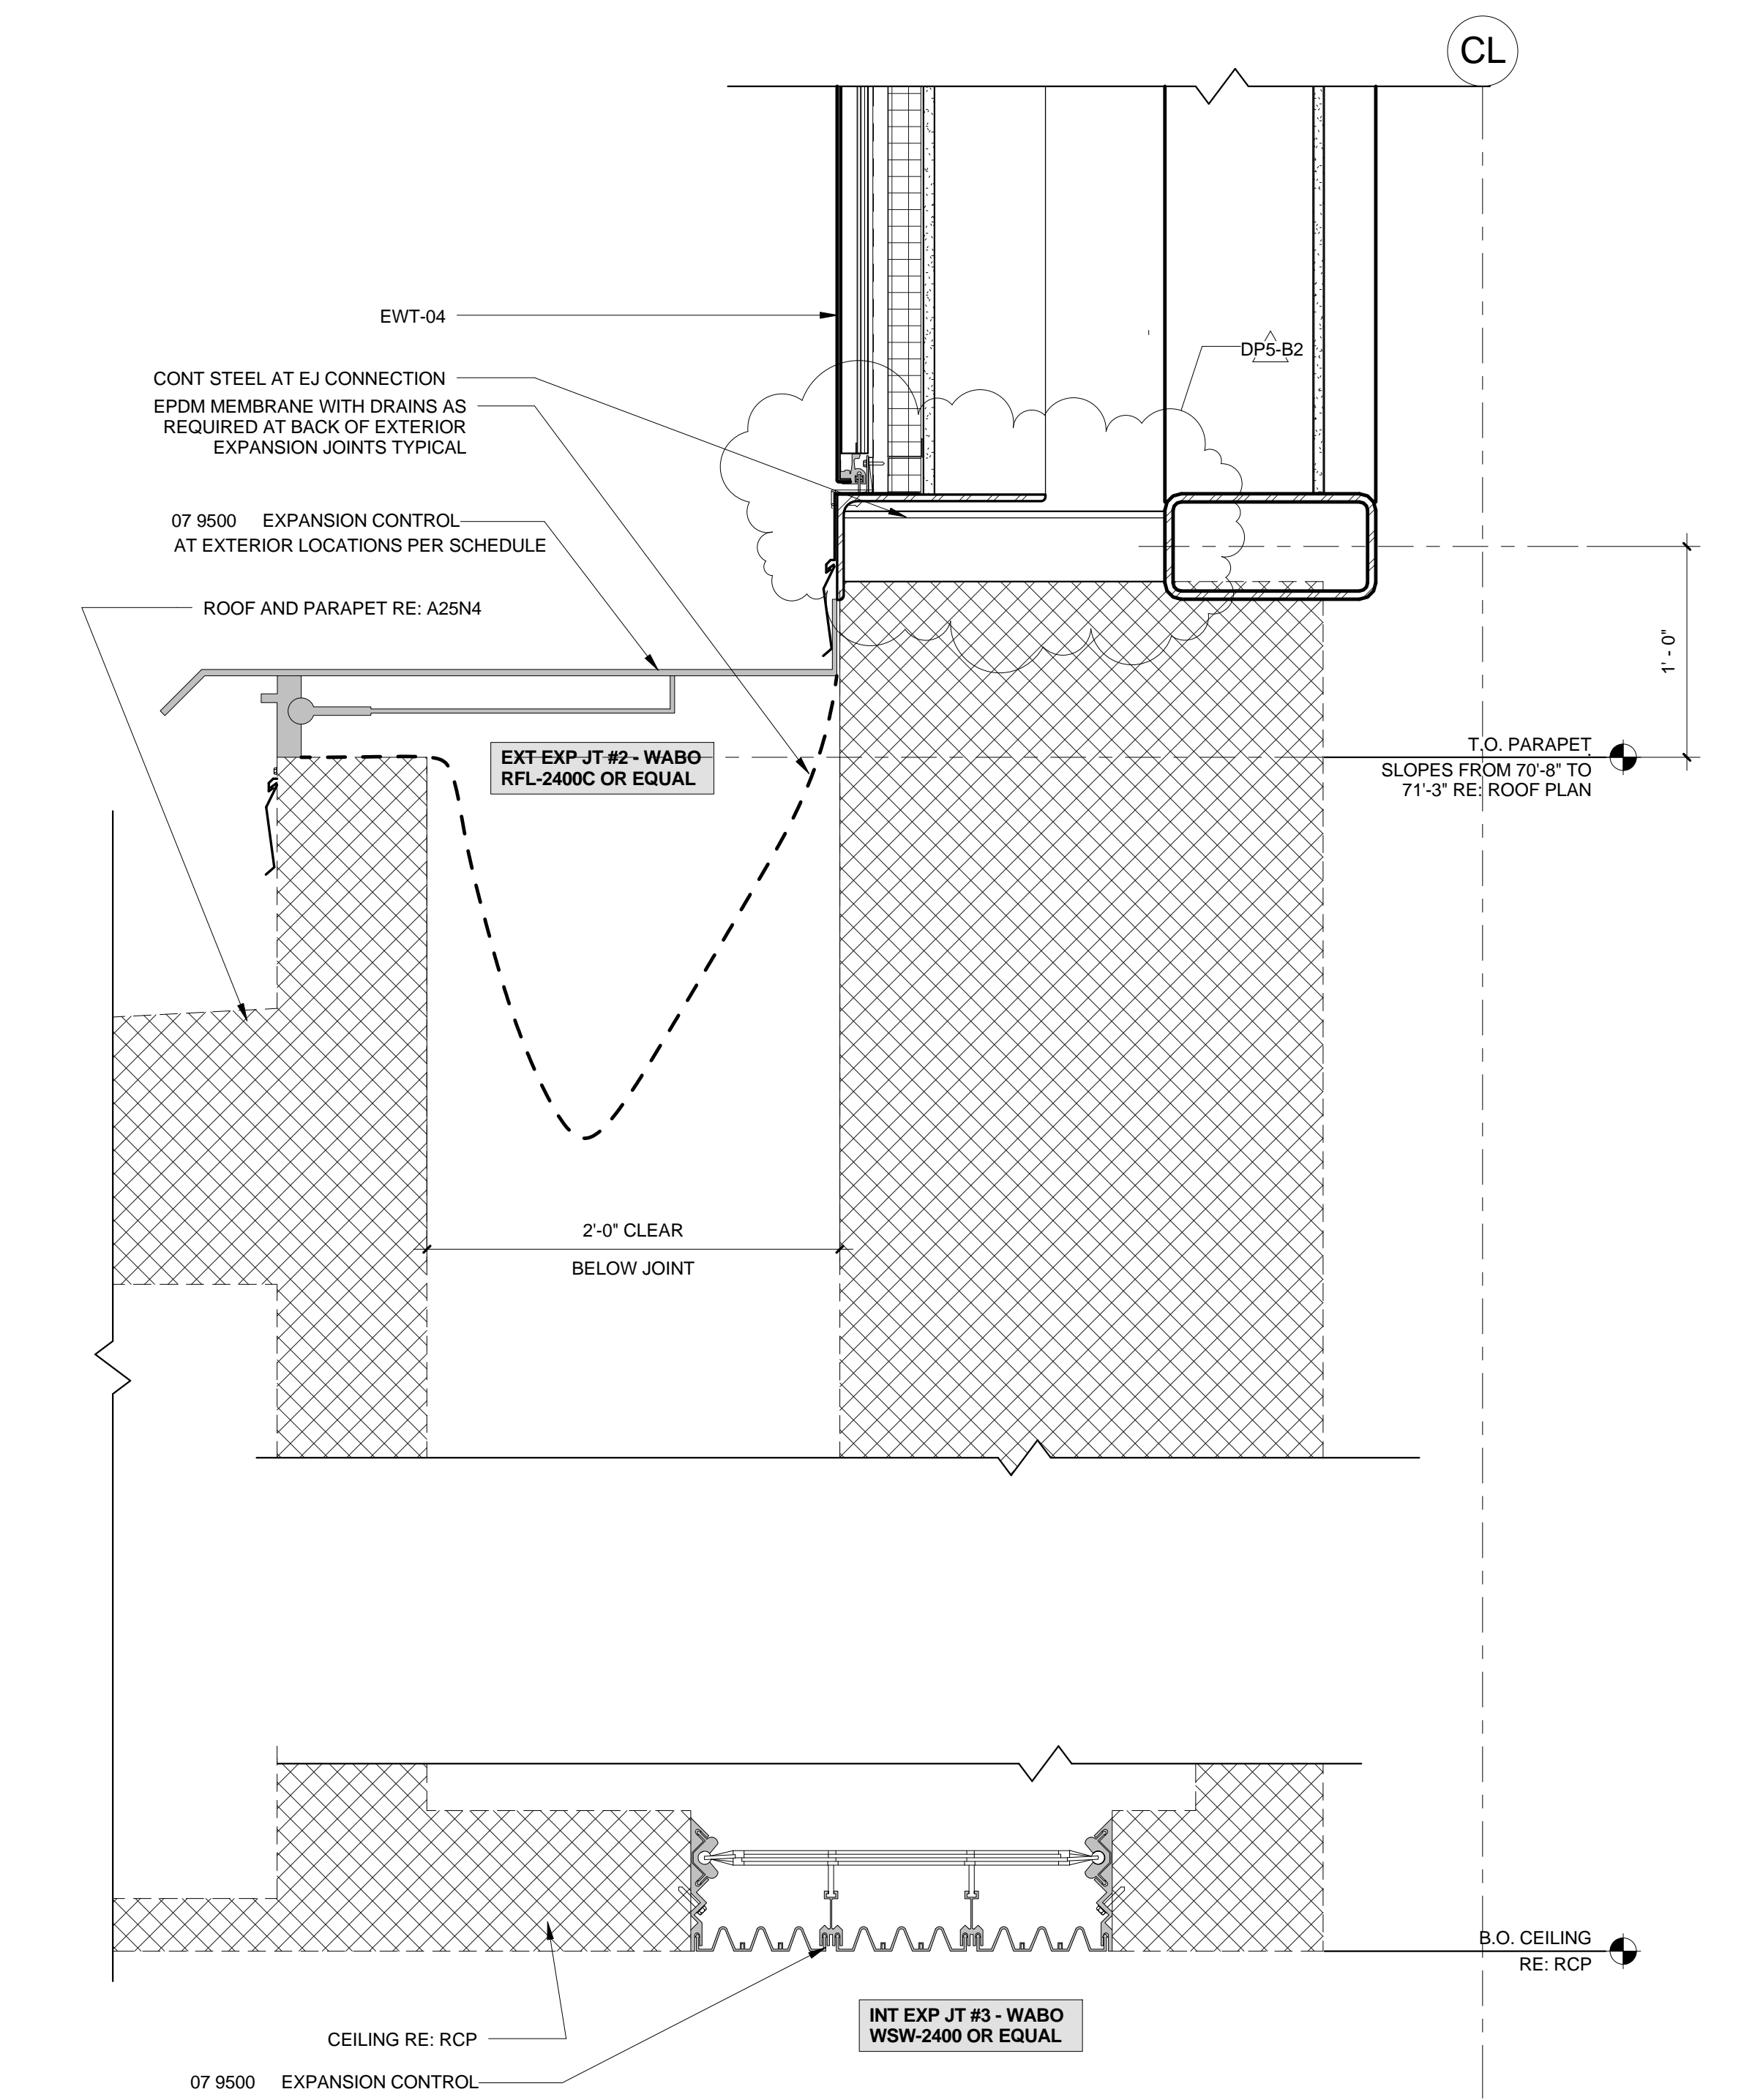
2 AS103/A7318 1 1/2" = 1'-0"

SECTION DETAIL-SEISMIC JOINTS AT BUS GATE INTERFACE AT HIGH ROOF

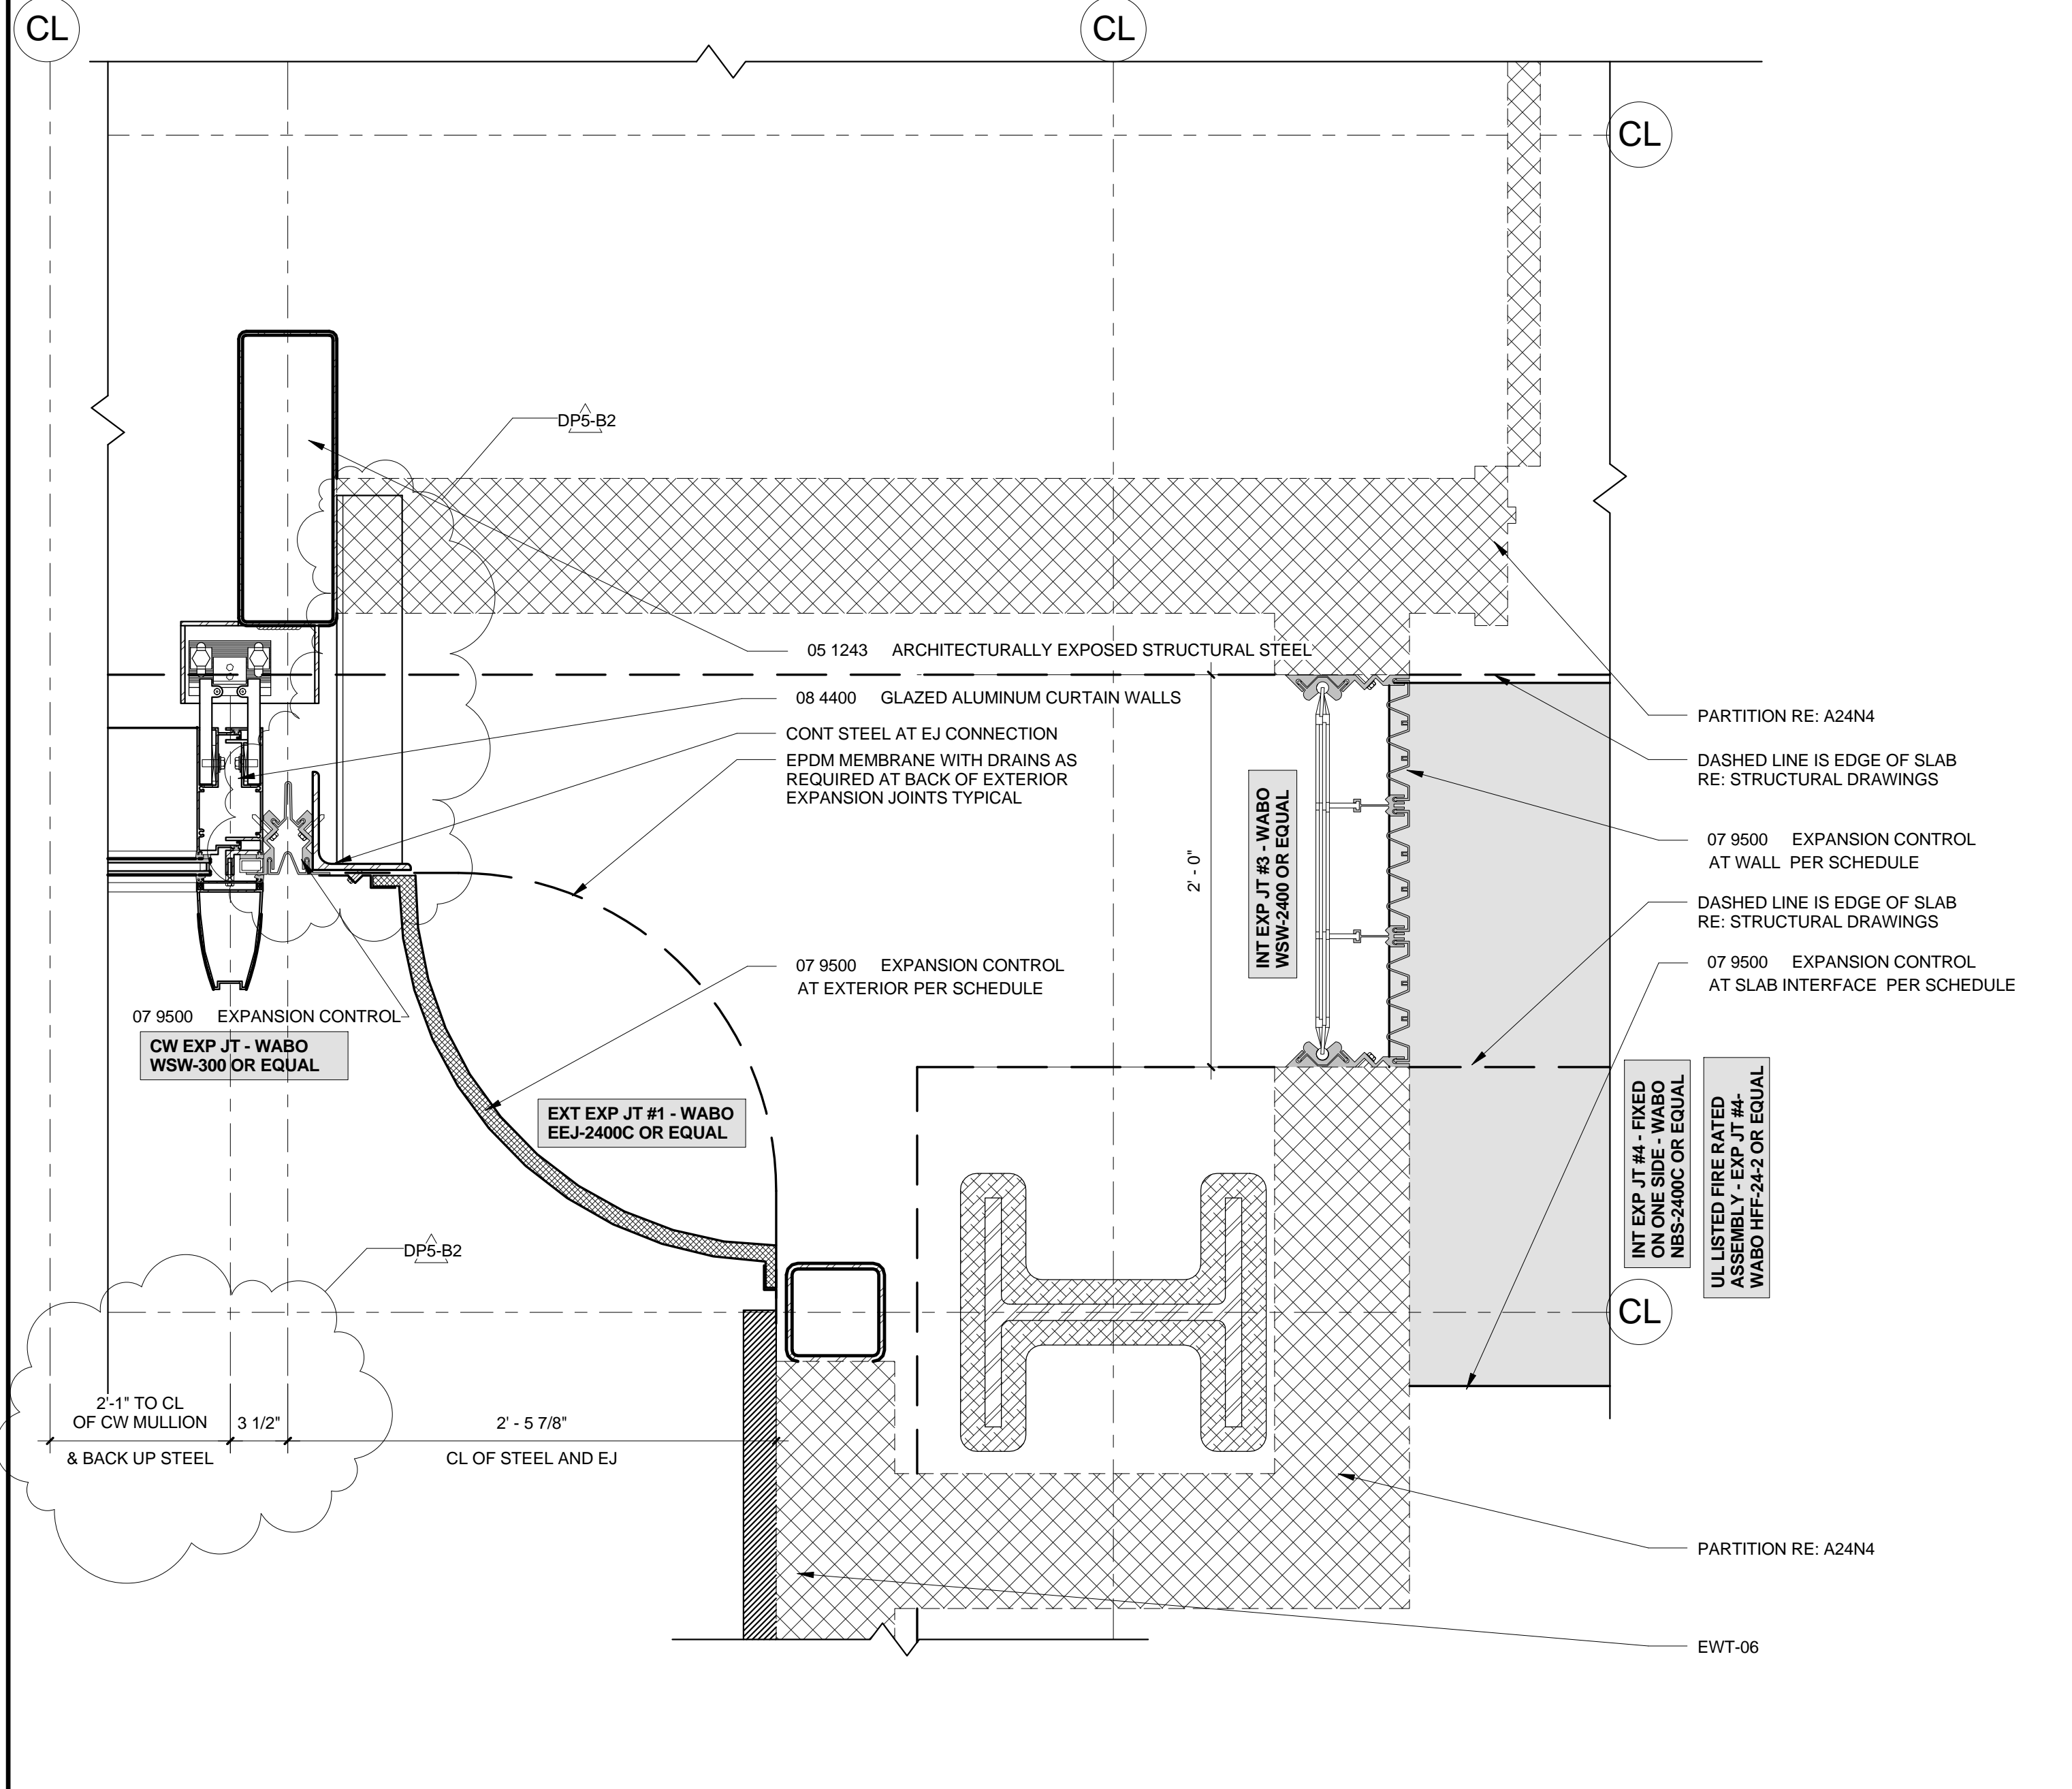
5 AS103/A7318 1 1/2" = 1'-0"

PLAN DETAIL-SEISMIC JOINTS AT BUS GATE INTERFACE NEAR GRIDLINE N19

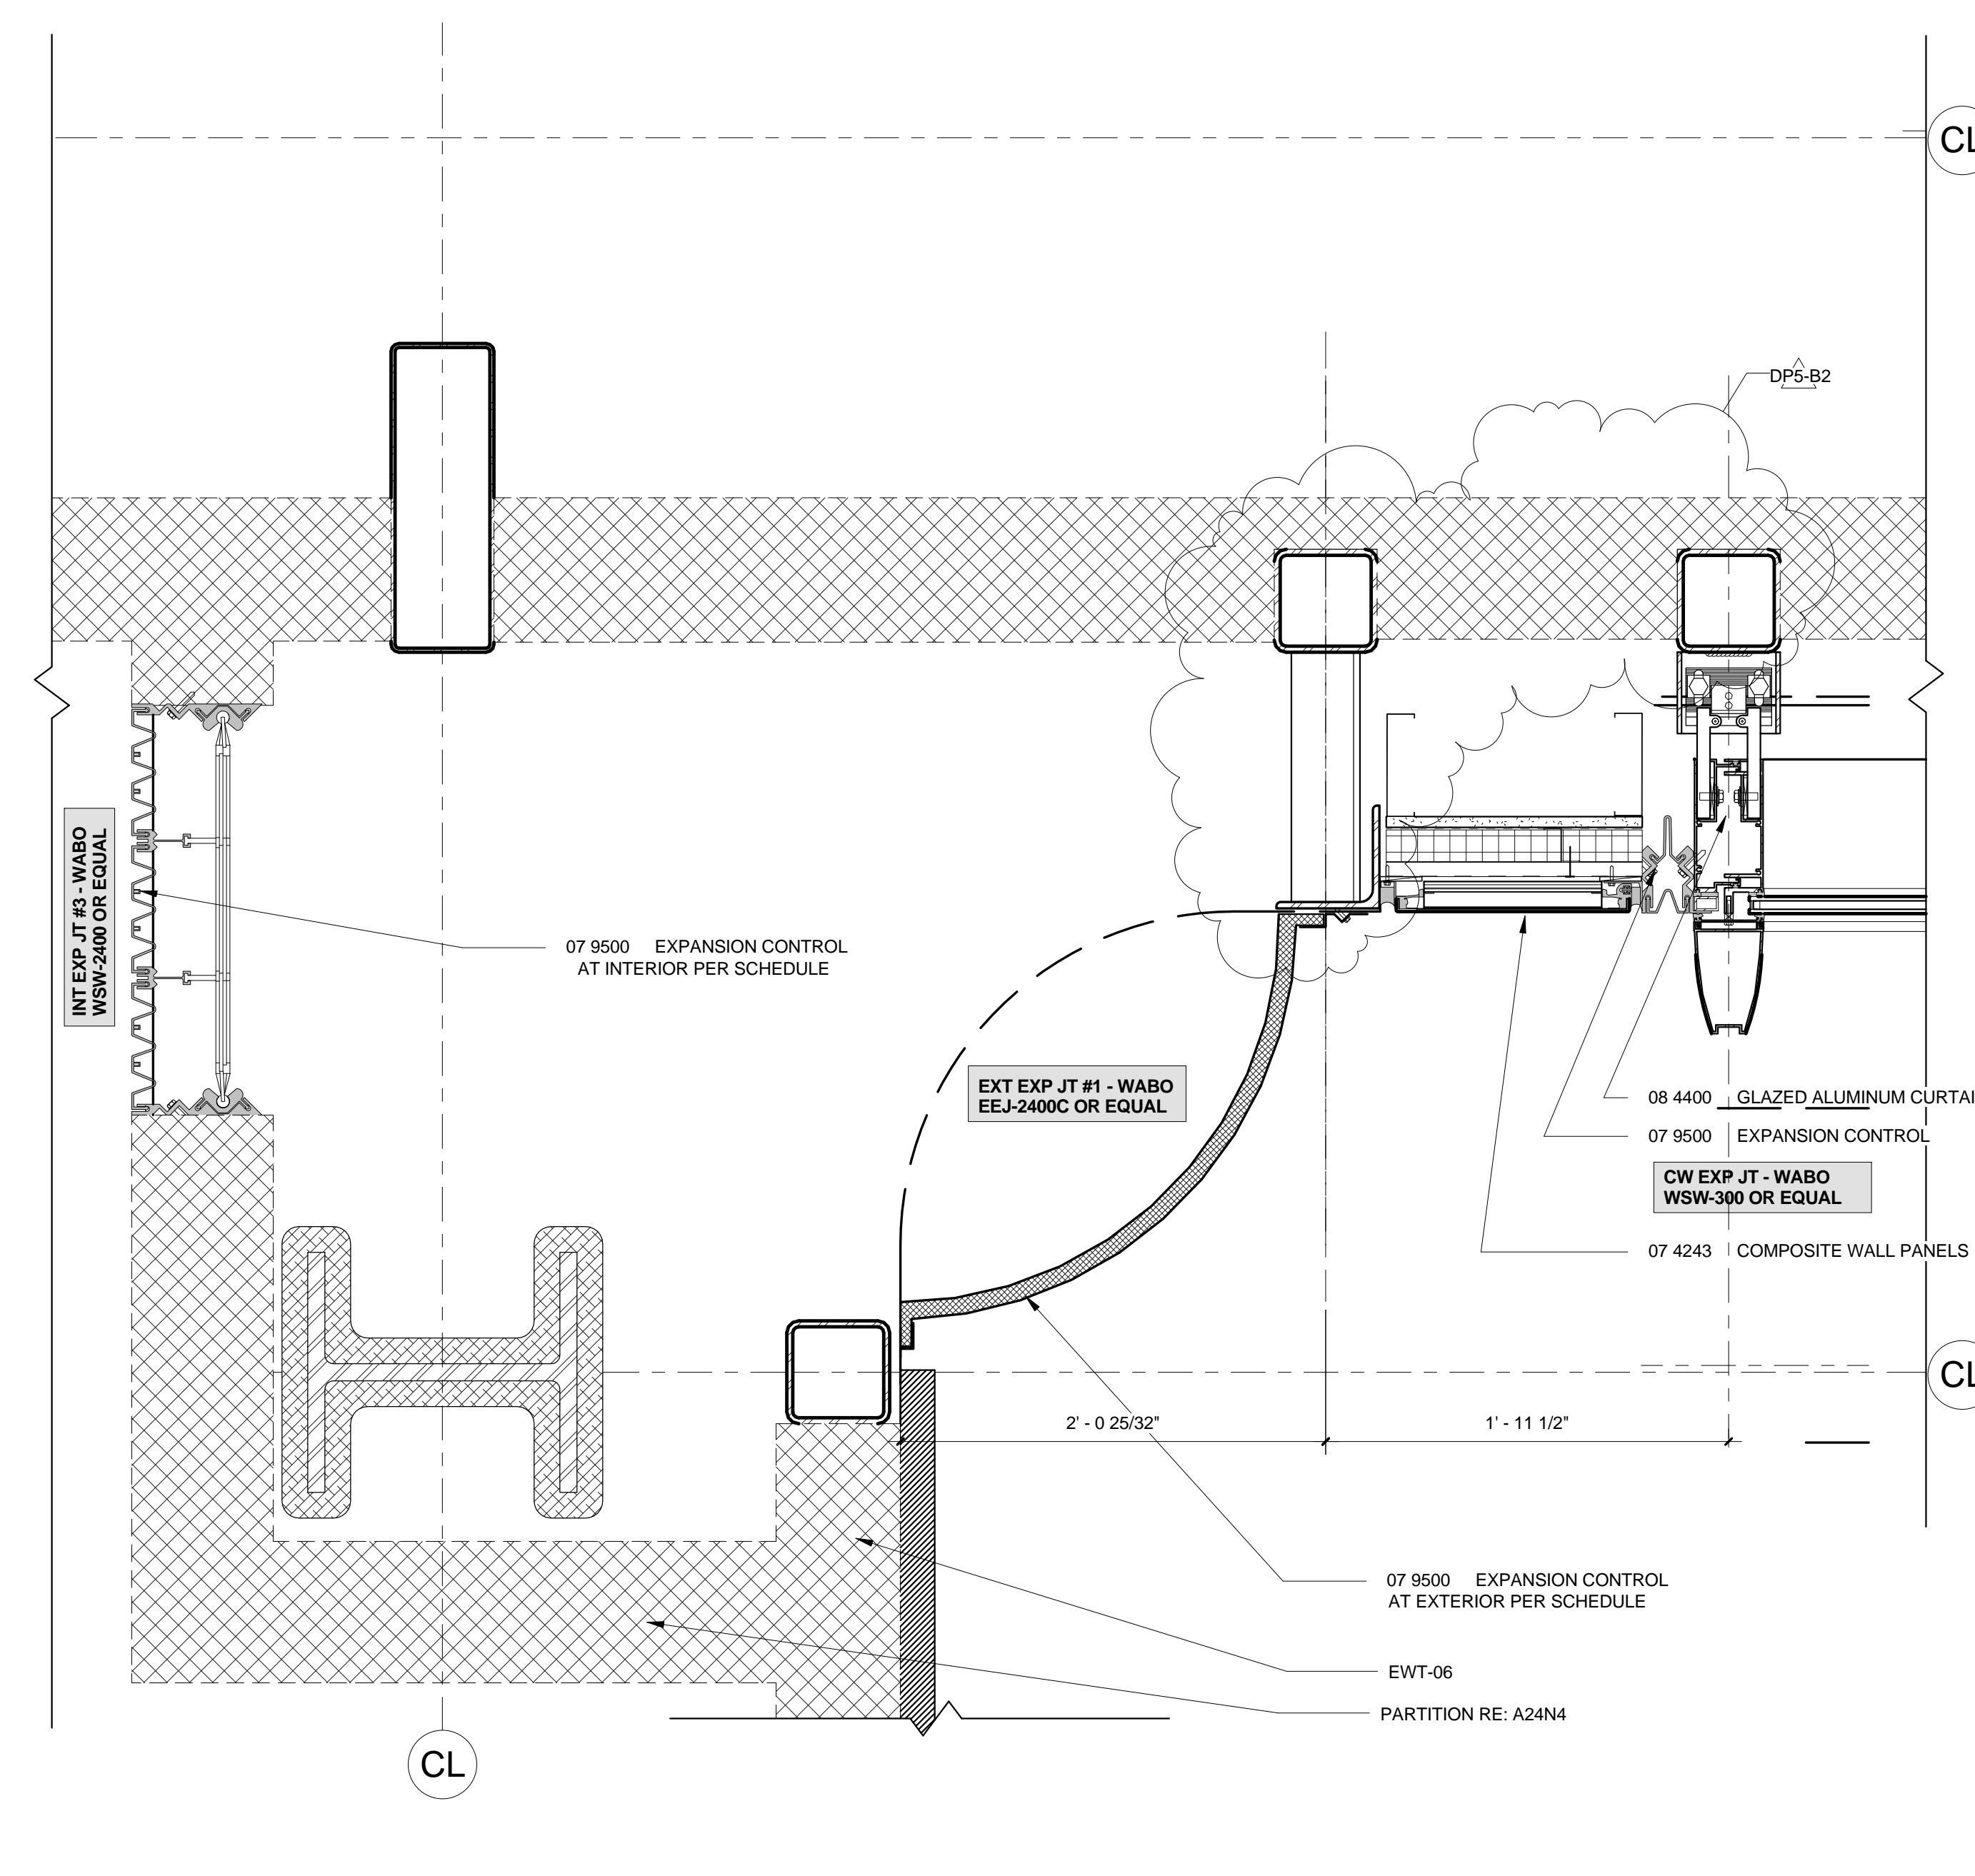
3 AS103/A7318 1 1/2" = 1'-0"

PLAN DETAIL-SEISMIC JOINTS AT BUS GATE INTERFACE ABOVE ROOF NEAR GRIDLINE N20

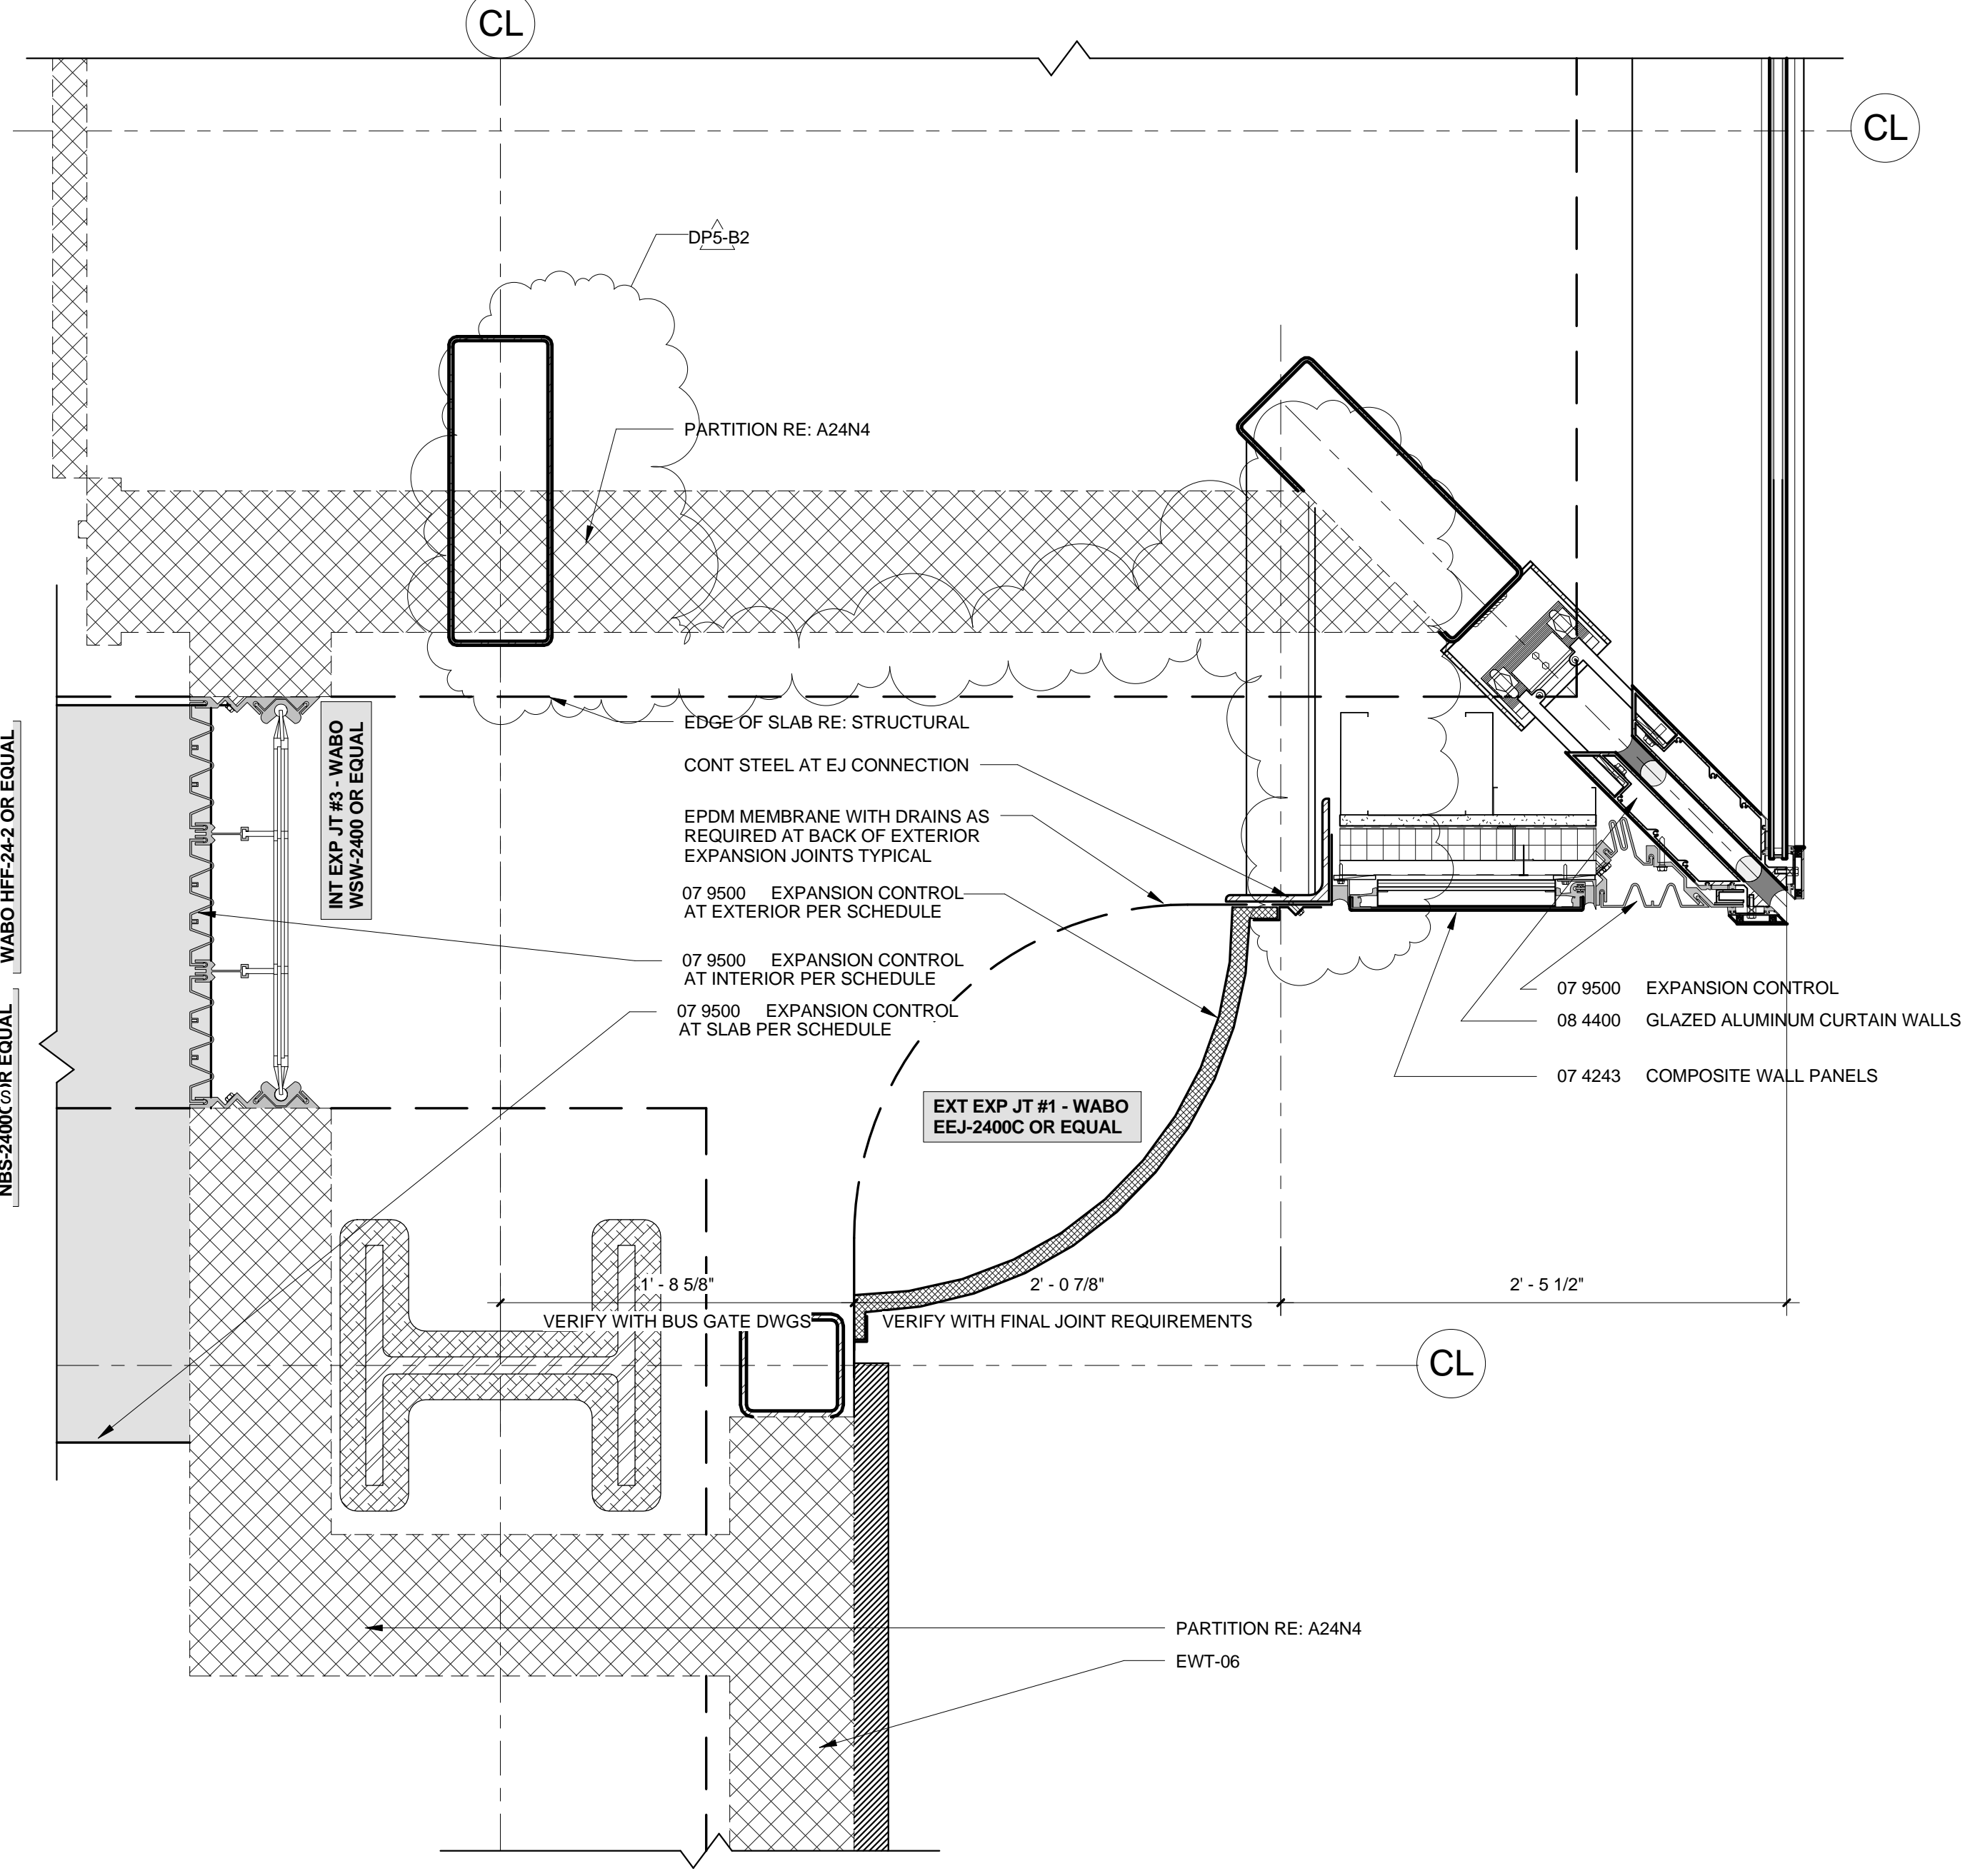
1 AS103/A7318 1 1/2" = 1'-0"

PLAN DETAIL-SEISMIC JOINTS AT BUS GATE INTERFACE AT WEST SIDE NEAR GRIDLINE 21
